Apex Project Number 1123-202

December 19, 2023

Reference: Asbestos Containing Materials Assessment

Columbia Apartments 2131 Slighs Avenue Columbia, South Carolina

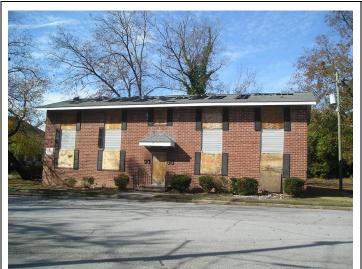
Photo 1 – Front view Columbia Apartments.

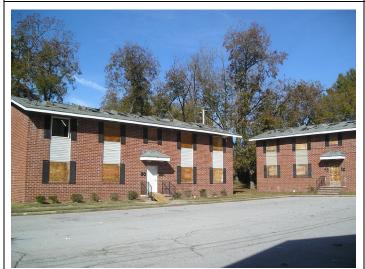
Photo 3 – Typical front view of Apartments.

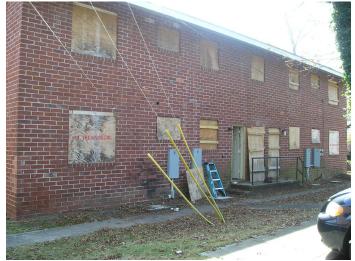
Photo 4 – Typical view of rear of apartments.

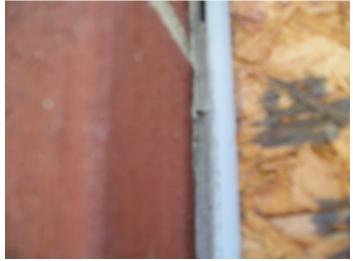
Photo 5 – Typical view of window caulk.

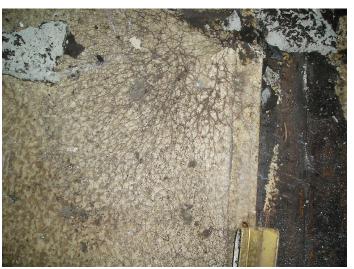
Photo 6 – Typical view of Kitchen flooring.

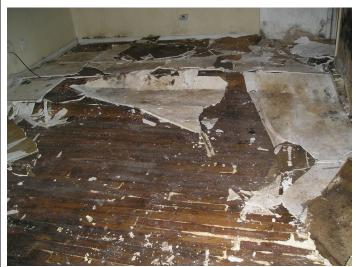
Photo 7 – Typical view of collapsed ceiling and hardwood floors.

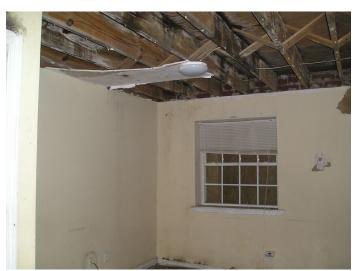
Photo 8 – Typical view of the collapsed ceiling.

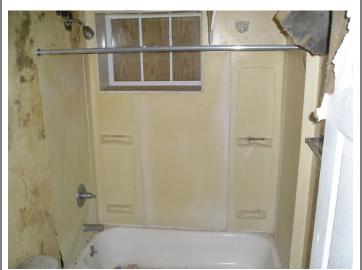
Photo 9 – Typical view of tub surround.

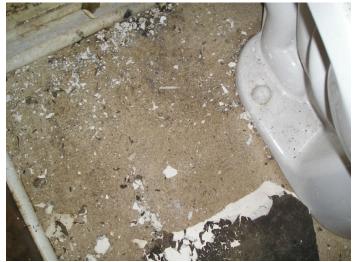
Photo 10 – Typical view of vinyl bathroom flooring.

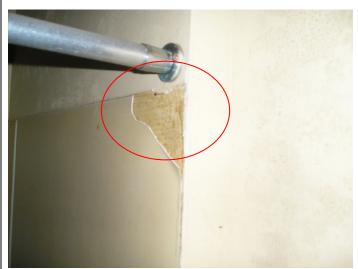
Photo 11 – Typical view of tub surround mastic.

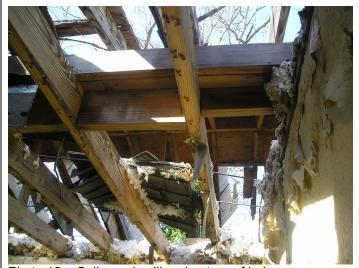
Photo 12 – Collapsed ceiling due to roof holes.

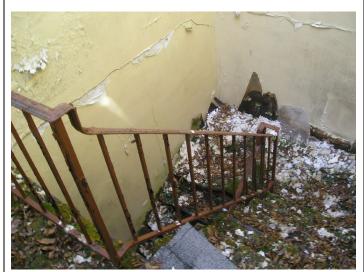
Photo 13 – Entry stair well with plaster and stair tread.

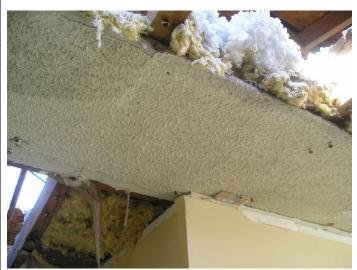
Photo 14 – Upstairs ceiling texture.

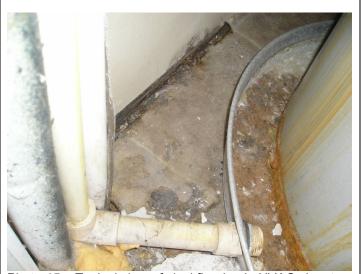
Photo 15 – Typical view of vinyl flooring in HVAC closets.

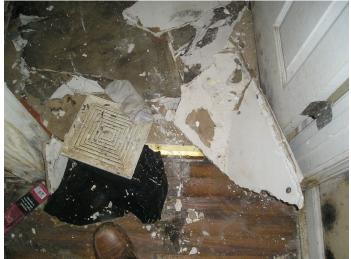
Photo 16 – Two layers of bathroom vinyl flooring.

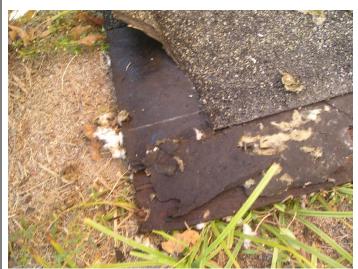
Photo 17 - Roof shingles and felt.

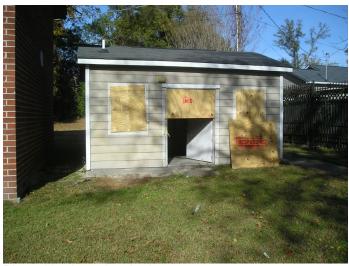
Photo 18 – Laundry shed.

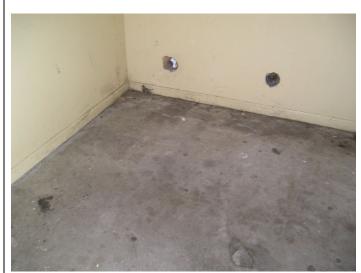
Photo 19 – Laundry shed drywall with concrete slab.
